December 9, 1991

RE: B&W Contract RB-615, Unit #2
Burners

Test Data for "B" Pulverizer

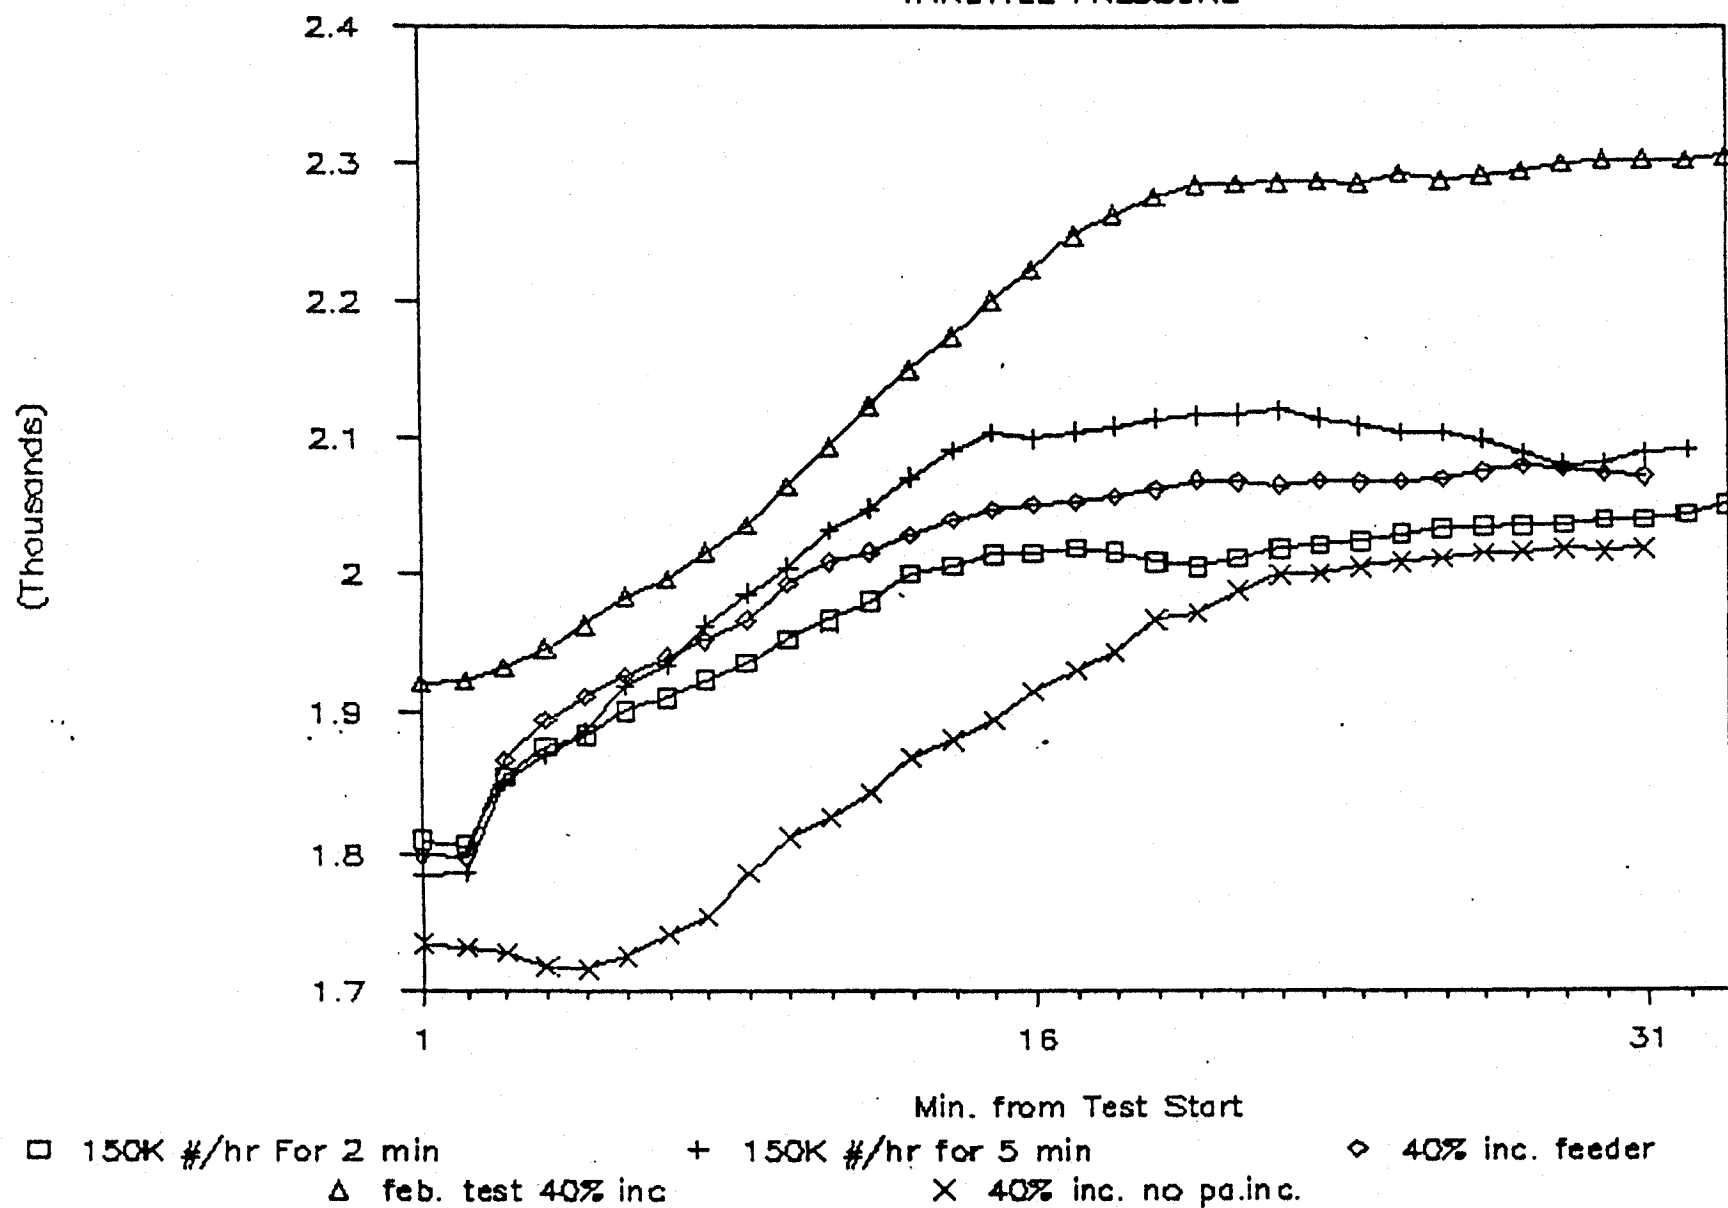
THROTTLE PRESSURE

You will find enclosed the photographs from my recent visit, as well as my report to Barberton. For the most part, this is self explanatory. In addition, I have enclosed data from some pulverizer response testing that I was involved in some years back. This is in reference to the comments concerning turndowns that I observed. This is for your info.
